Sutter Creek Community Benefit Foundation

March Newsletter, 2021

A Pictorial Retrospective The Historic Sutter Creek Grammar School

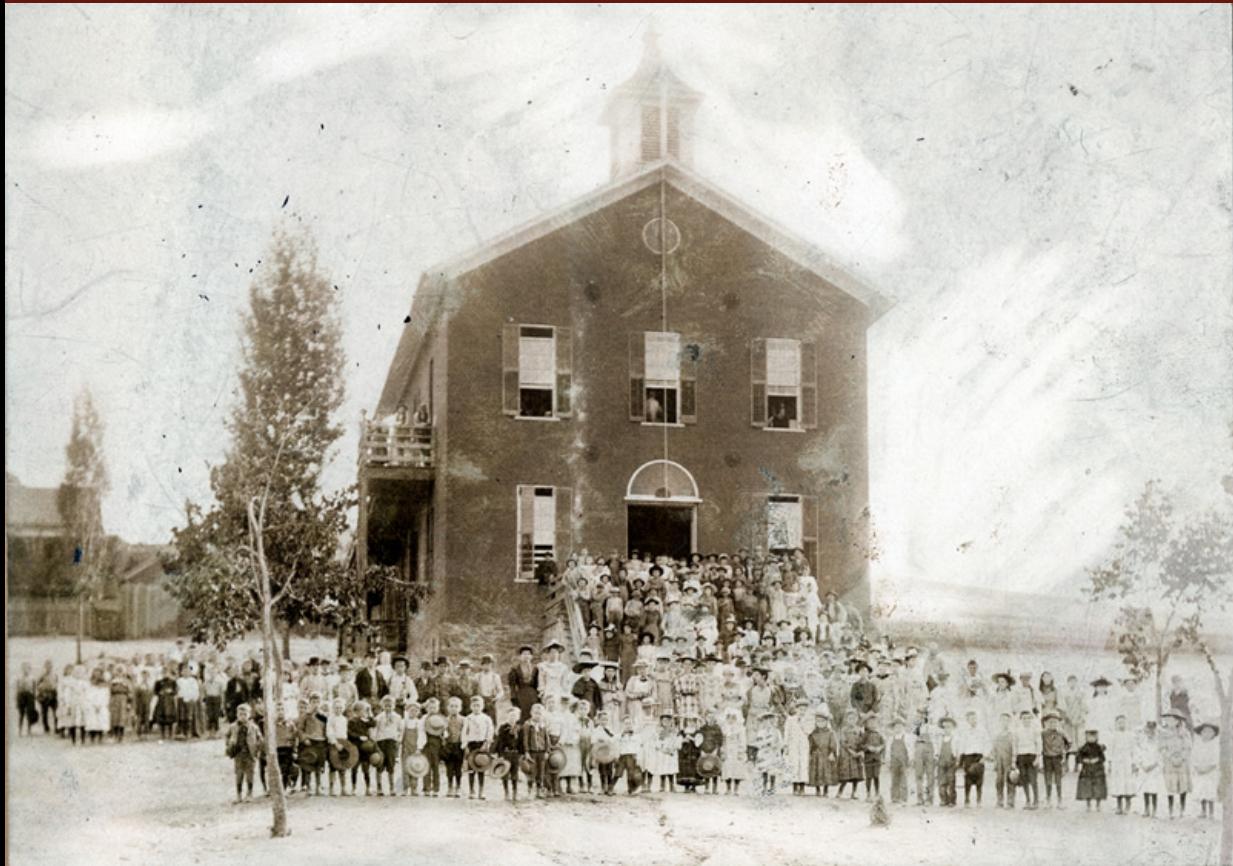
1870's - 1880's Observations:

- Flagpole appears to sit atop a platform over front door although hard to tell from this angle
- Small trees
- Front stairs are still straight sided
- Cole Street appears to be in place
- Building has been painted dark red - remnants of this paint have been uncovered and preserved
- Porch roof yet to be built
- Entrance/exit stairs on left go to door at front - now a window
- White trim around windows
- First appearance of "cabin" in back
- Cupola vents have been enlarged and cupola itself may have been rebuilt
- Note all the kids have hats!

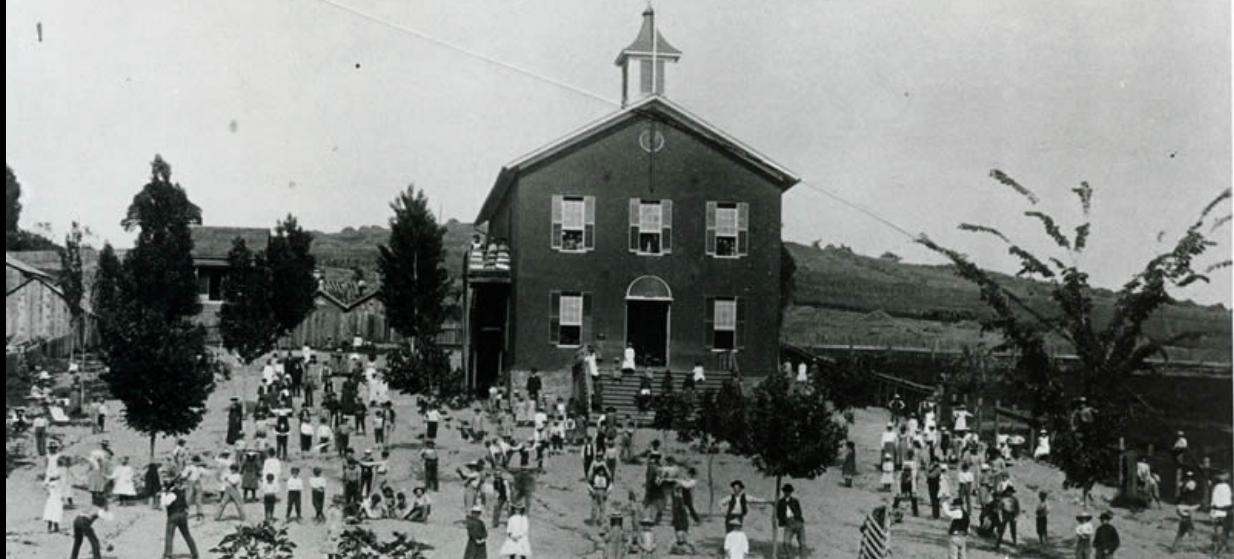
1890's - 1895 Observations:

- Full height flagpole with flag after 1890 above cupola - flag had to be raised from ground or 2nd floor window
- Fence on right, Cole Street behind
- Dark (red) color
- Outhouses or storage sheds at rear (lumber looks new)
- Hay stacked in field behind - kids traveled by horse!
- Front play yard retains natural slope
- Trees relatively small
- Ball on cupola changed to small size and weather vane removed
- Cupola has added top under ball

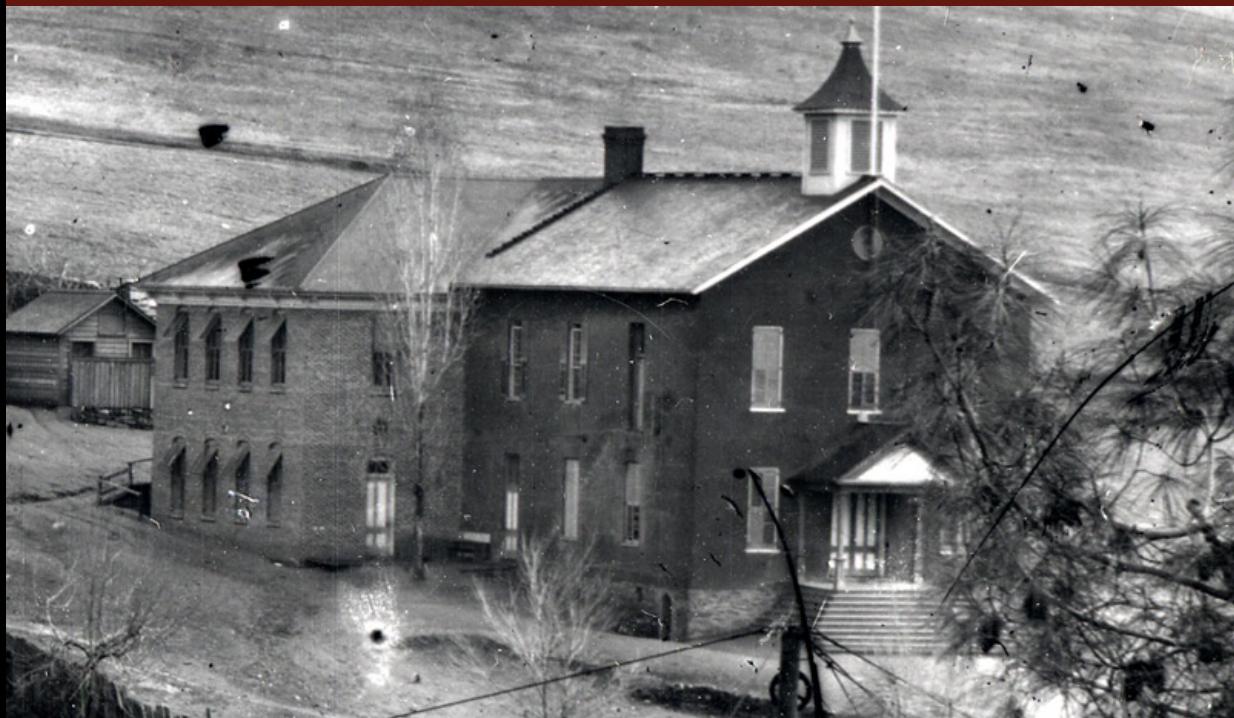
Mid 1890's Observations:

- Rear addition newly constructed, not yet painted
- Front porch roof added with catwalk on top
- Original building still dark (red)

- Door still in place in 1st window, 2nd floor
- Entry/exit structure on 2nd floor exterior removed
- 3rd window on 1st floor converted to door
- Flagpole in place, lower portion dark (to match building color?)
- Front entry stair side steps in place
- Shutters changed to second type
- Outhouses in back
- Probably no wooden extension in back - evidenced by handrail along drainage ditch
- Small windows in rear addition
- Single chimney with access ladder
- Catwalk from chimney to cupola
- On right - school access road visible, while Cole Street continues above and behind
- Most trees gone - must be winter - no leaves!
- No sign of mine structures on hill behind school
- Terracing and retaining wall evident at lower front
- Chimney by door in new addition yet to be constructed
- Only 3 windows on side of 2nd floor in front section

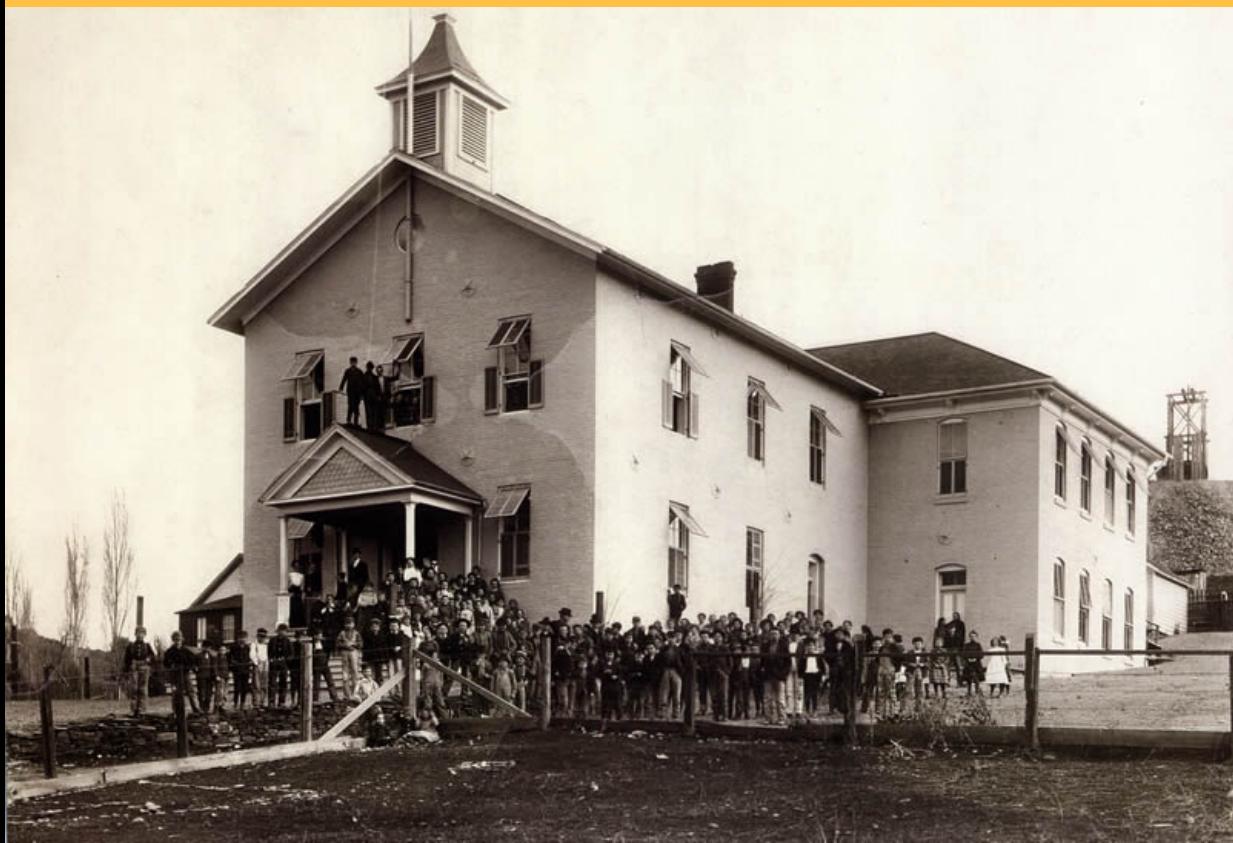
Late 1890's - Early 1900's Observations:

- Boys on porch roof! Handrail in place, flagpole rope can be seen (Note: inside 2nd floor front room, a notch in the center window sash can be seen where a short set of steps once provided access to front porch roof)
- Entire building painted white, but not stuccoed (marks in photo are from water on negative)
- Second type shutters in place with swing-out uppers
- Paint looks fresh, eaves are white, front porch posts are white
- Door in place at 3rd window, 1st floor (Note: window tops are flat - doorway tops are arched)
- Mine structure visible at rear - ventilation shaft (Emerson Shaft) for

Wildman Mine

- No secondary vent on roof yet
- Auxiliary buildings at rear
- Fence surrounding play yard

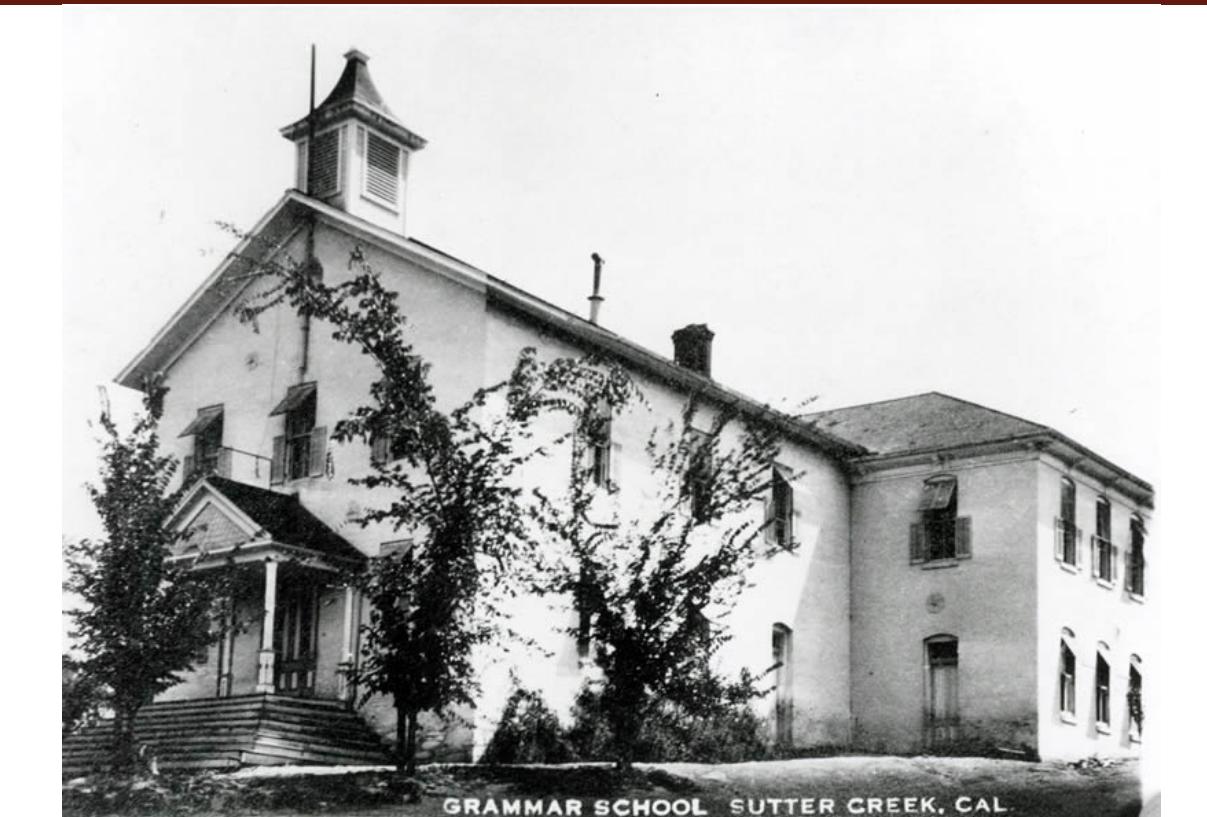
World War I - 1920's - Observations:

- Dark mud splash stain at base of building (no rain gutters)
- Short flagpole - was it broken? Still in use? Rope tied to rail
- Front stair sides still in place
- Catwalk and hand rail in place on front porch roof
- Windows in addition still have not been enlarged
- Secondary vent on roof
- Appears to be shingle or shake roof
- Front door repainted

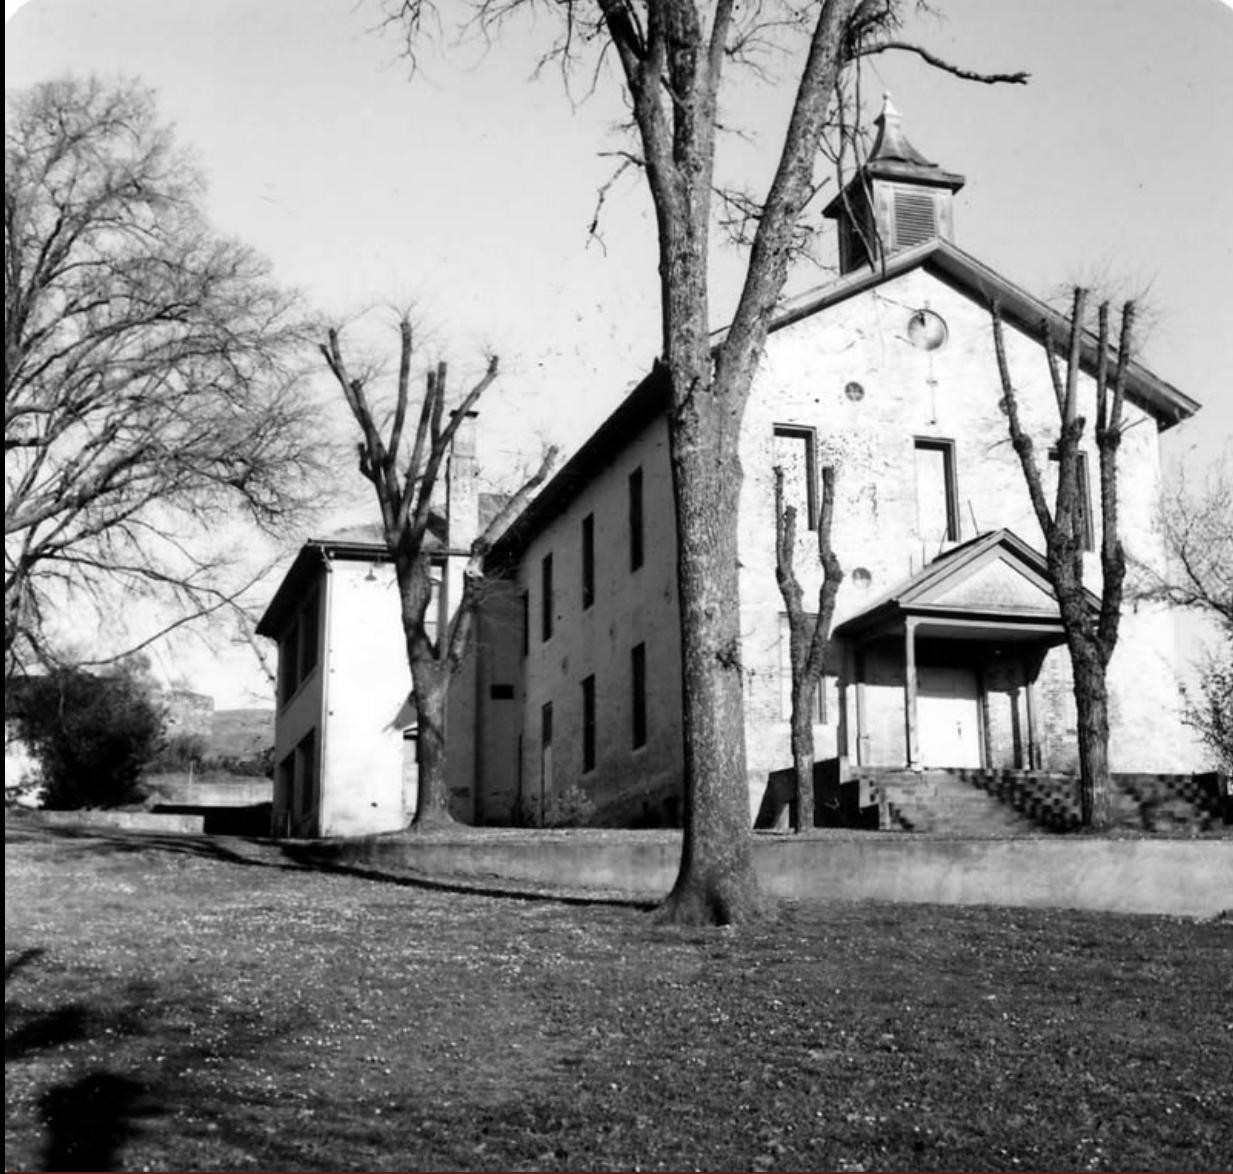
1950's - 1960's Observations:

- Large windows in addition, originals enlarged in '20's - '30's
- 2nd window on 2nd floor not yet converted to door
- Original door at first opening has been converted to window
- No flagpole - mounts in place
- Windows, at least in front, empty and boarded up
- Side steps on front stairs removed
- No shutters
- Rear window on 1st floor converted to door
- "Sunburst" above door covered
- Terrace retaining wall in place
- No fire escape or entry structure to 2nd floor yet
- Looks like tin roof
- Note chimney/installed behind tree partially covering door in addition
- 4th window has been added to side of 2nd floor

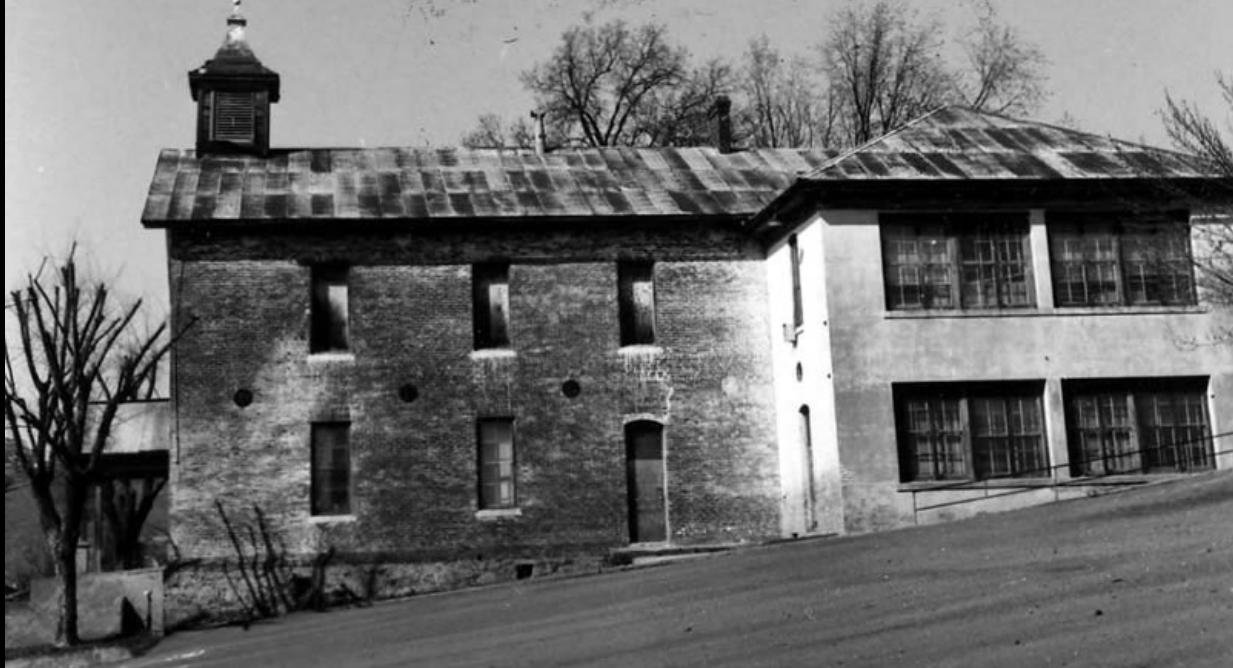
1970's - 1980's (Pre Woman's Club and then SCCBF Restorations)
Observation:

- A derelict
- Tin roof rusted
- Paint gone from west (original) half or weathered back to original red
- Flagpole gone
- Upper west windows gone and boarded
- Lower west windows boarded
- Front steps are straight sided - again
- Vent still in place between chimney and cupola
- No catwalk to cupola as seen in picture 4

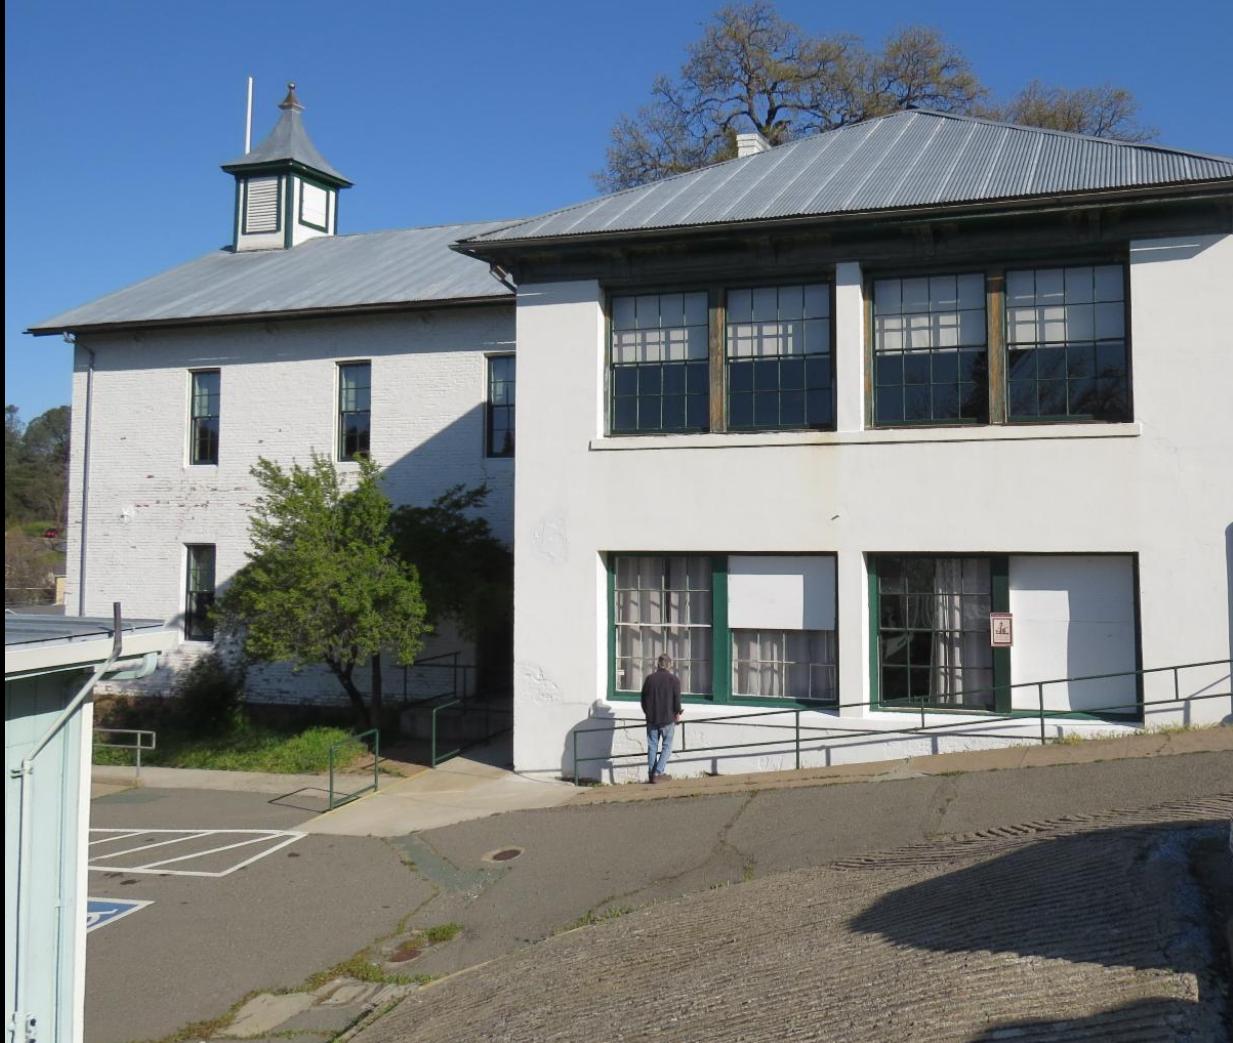
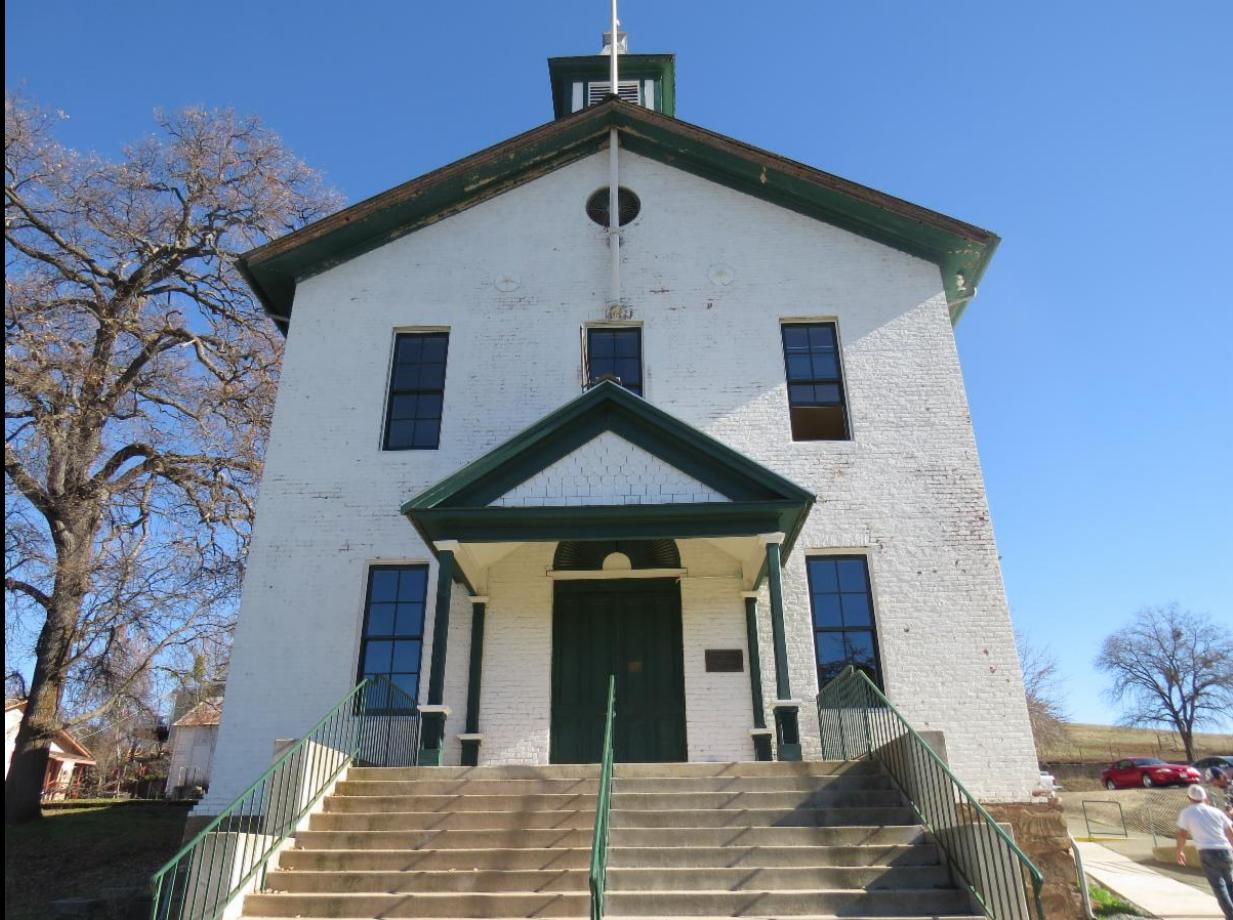
... and after a couple of extensive, not to mention exhausting restorations, Sutter Creek's own historic grammar school has reached the milestone of 150 years. Yes, folks, 150 years! The SCCBF is working on plans for a community celebration (tentatively in September). Everyone will be welcome to tour the school, share experiences, reminiscences, and maybe have a cool sip. We will keep in touch through this newsletter, our Facebook page, and the local newspaper. So comb through your closets and sock drawers for old school photos or artifacts (or if you have some stories to share) and contact us at tjmurphy31@gmail.com. The SCCBF is looking forward to opening up the school to share all that has been accomplished to date with the generous donations that have been received. Thank you for your ongoing interest and support as we continue to make progress with our work plan.
